平成 13 年度～平成 15 年度科学研究費補助金（基盤研究(B)(2)）研究成果報告書

メコン川下流（カンボジア）の地形と洪水災害に関する研究
Research on Geomorphological Features and Floods in the
Lower Mekong Plain in Cambodia

研究代表者 久保純子（早稲田大学教育学部 助教授）

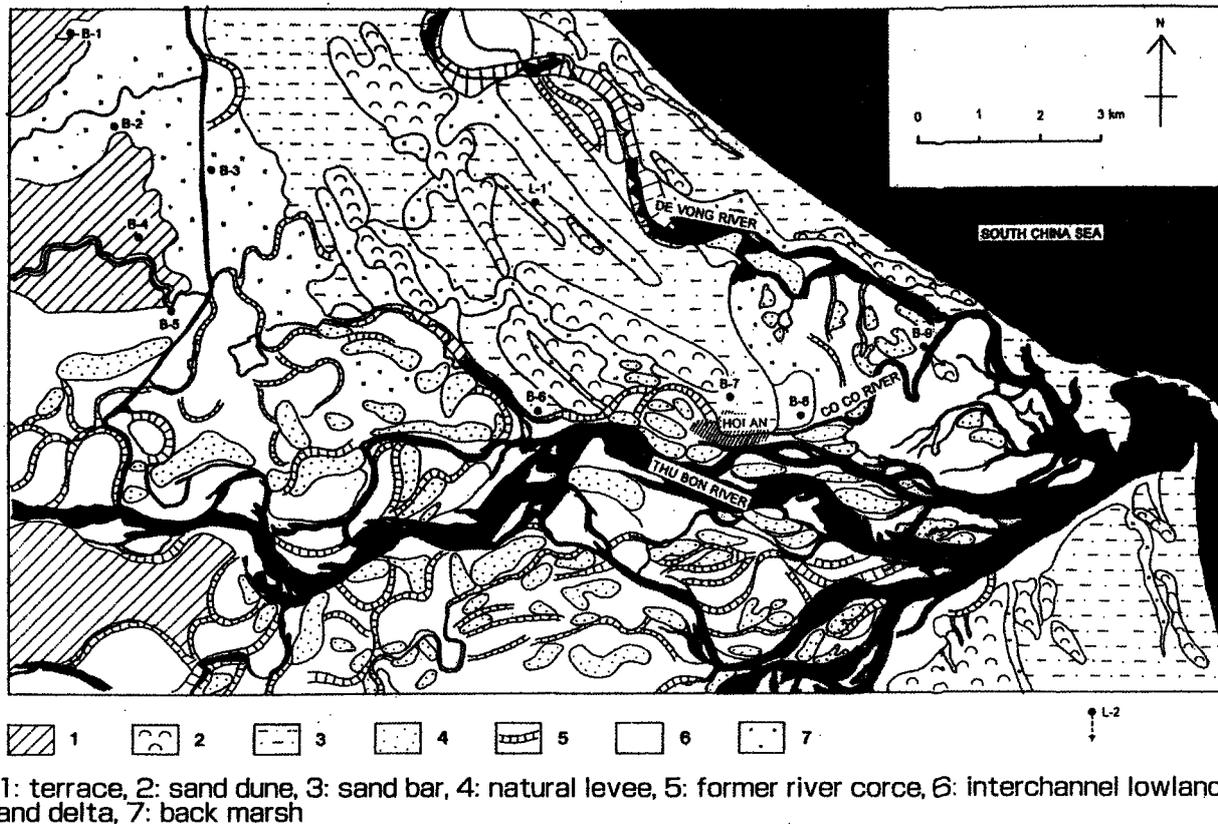
Fig. 4. Geomorphological map of the Lower Thu Bon River Plain (Kubo, 2000a)

The geomorphological map of the Lower Thu Bon River Plain, showing features such as natural levees and former river channels, was prepared by the author (Fig. 4, Kubo, 2000a). The aerophotos used were kindly shown to the author by the Faculty of Geography, Ha Noi National University.

According to the map, the geomorphological features of the Lower Thu Bon River Plain are as follows:

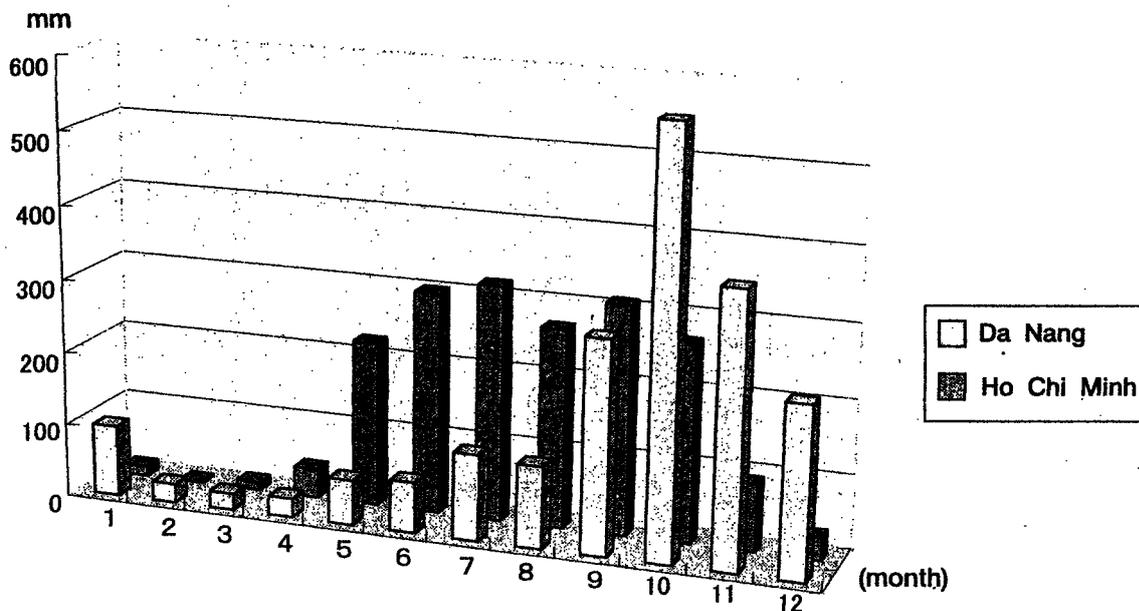
Fig. 5. Mean monthly rainfalls in Da Nang and Ho Chi Minh (National Astronomical Observatory, 2000)

Figure 5 shows mean monthly rainfalls in Da Nang (central Vietnam) and Ho Chi Minh City in the southern part of the country. In Ho Chi Minh City the rainy season starts in May and lasts until October, and the monthly rainfalls sustain about 300 mm over the rainy season. In contrast, the rainy season in Da Nang seems to start in September and lasts until December. The total rainfall in September, November, and December is about 300 mm, but in October it is about 570 mm, much higher than during any other months of the year, or in any other places in the country.

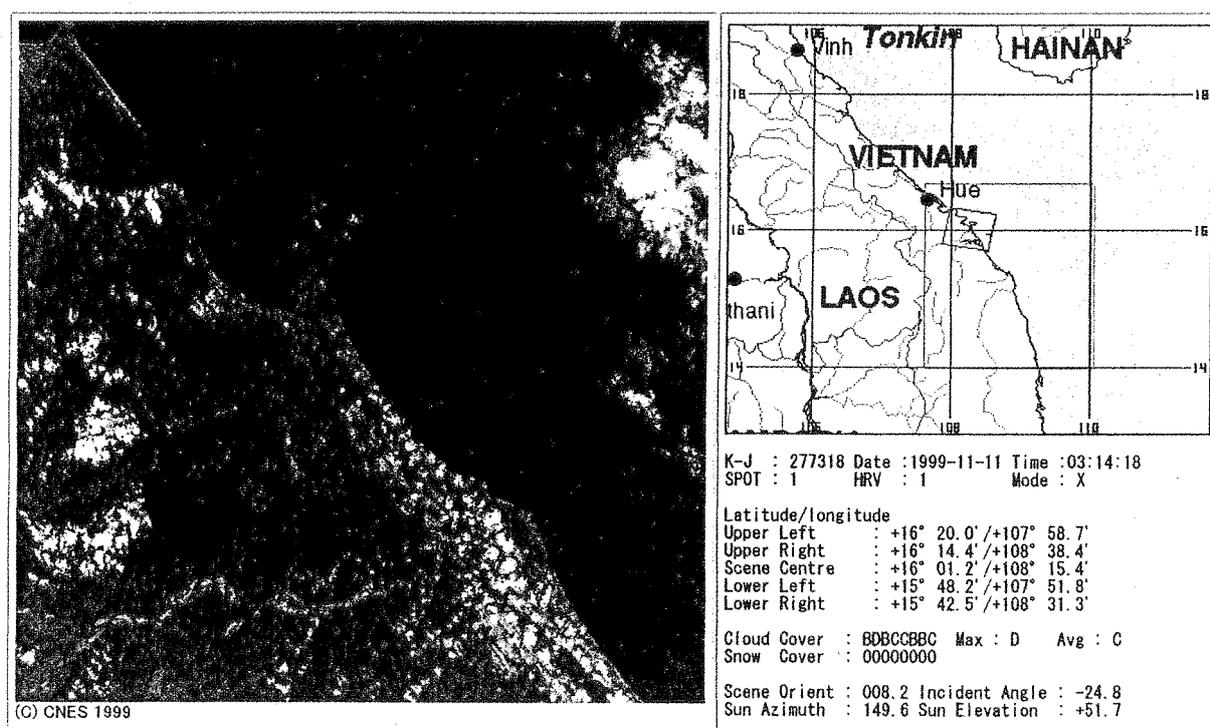
Fig. 6. An example of SPOT image (Nov. 11, 1999, CRISP's website)

The SPOT images taken on Nov. 10th and 11th, and the RADARSAT image on Nov. 7th will improve the geomorphological studies in this area focusing on the flood hazards of Nov. 1999, since they show the area of inundation. It is vital for further work to be done in cooperation with Vietnamese geomorphologists and the government.

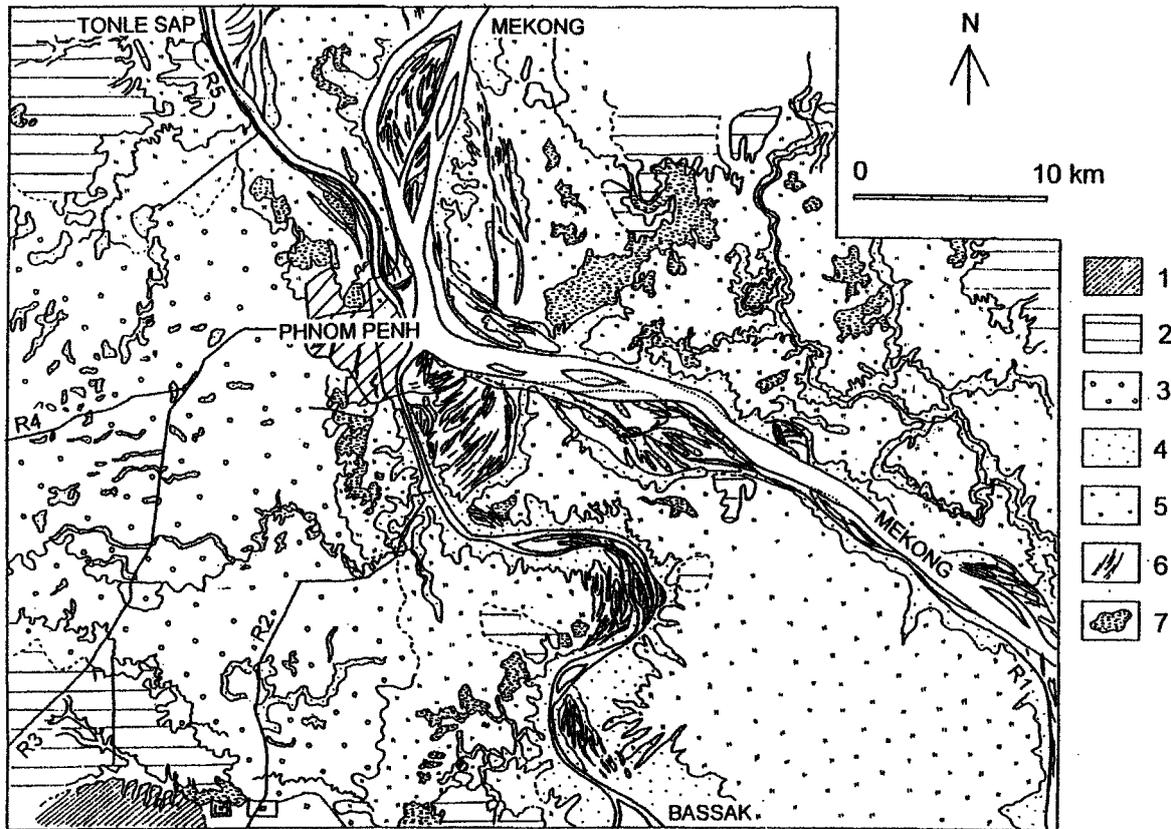
Fig. Geomorphological Land Classification Map around Phnom Penh

- 1: mountain and hill, 2: upland, 3: gentle fan, 4: natural levee,
- 5: back marsh, 6: former river channel, 7: pond, swamp

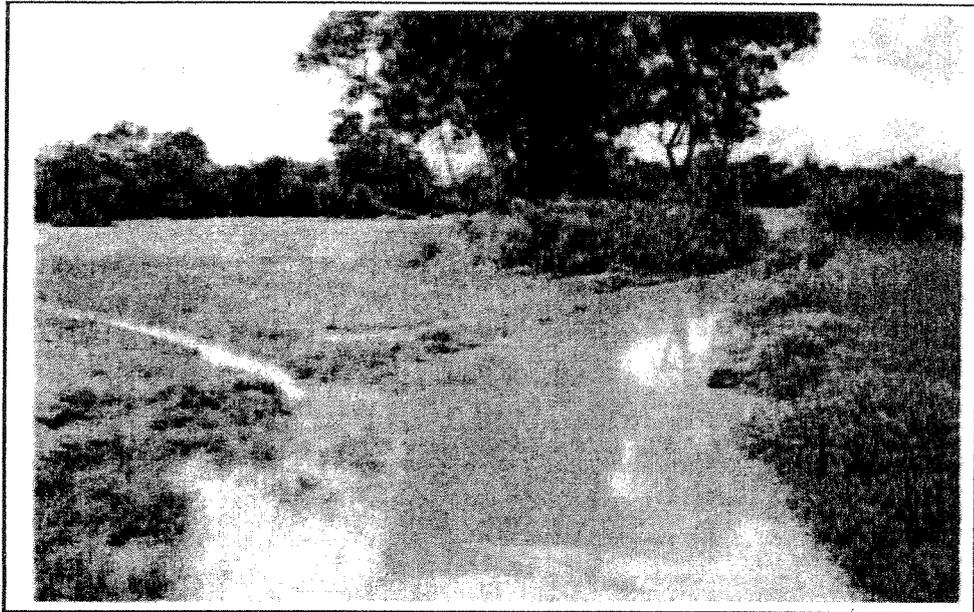
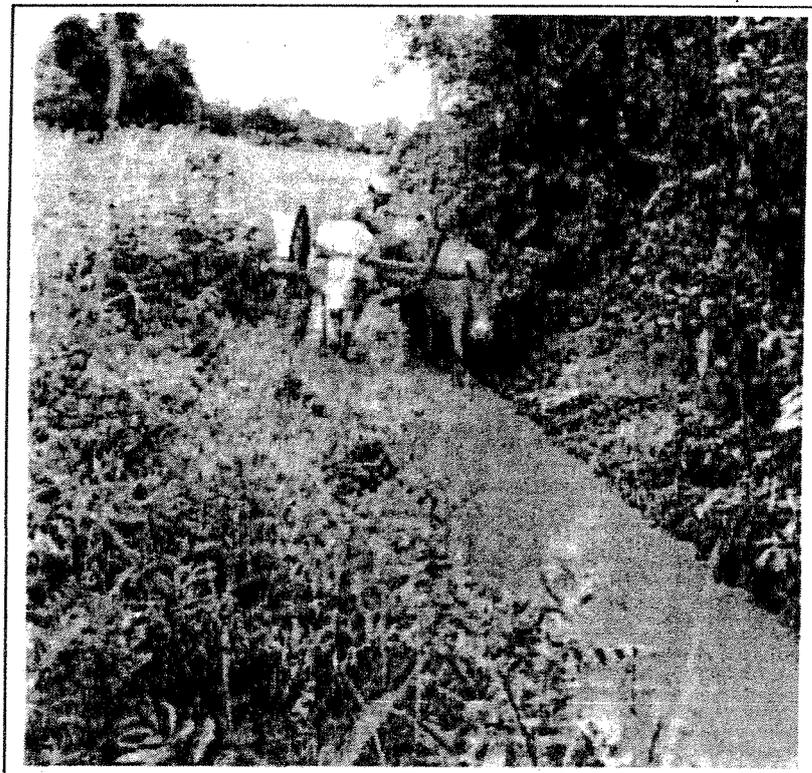
Picture 2. Every rice field of *Sambo* has a water inflow passage in the north and an outflow passage in the south. This was designed according to the naturally high ground at the north and gradually low to the south. In this picture a water flow with a traditional fish trap (Trou): rice gets water, farmer gets fish.

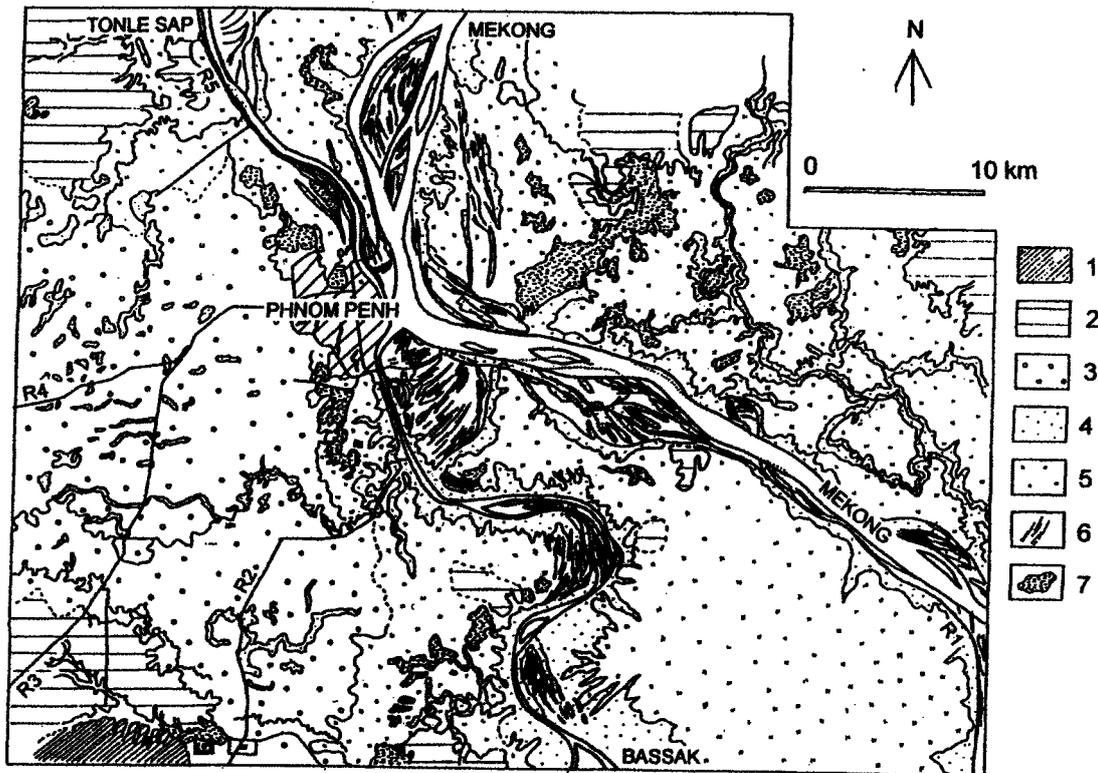
Figure 2. Geomorphologic Map around Phnom Penh

Upland terraces surrounding the plain are separated from the lowlands by very low cliffs. Small valleys locally incise these uplands. Monadnocks (residual hills) and surrounding gentle slopes are present at Phnom Thuma Doh, in the southwest. This gentle slope is a pediment, and lacks streams and valleys. The margin of this pediment slope gradually merges with the surrounding plain. Some monadnocks, such as that of Wat Phnom in Phnom Penh, Phnom Baset, and Phnom Oudong, are isolated in the plain, like islands. Some isolated uplands are also present in the lowland area.

The western part of the plain also consists of slightly higher areas. A gentle alluvial fan is present along the Prek Tnaout, a small tributary originating in the western hills. The gradient of this gentle fan slope is about 1/1000, and riverbed deposits are mainly fine sand and silt. Natural-levee-like features present on this gentle fan have a west-east orientation. Abandoned meandering channels are locally present on the surface. The city of Phnom Penh is located at the eastern margin of this gentle fan.

1: mountain and hill, 2: upland, 3: gentle fan, 4: natural levee, 5: back marsh, 6: former river channel, 7: pond, swamp

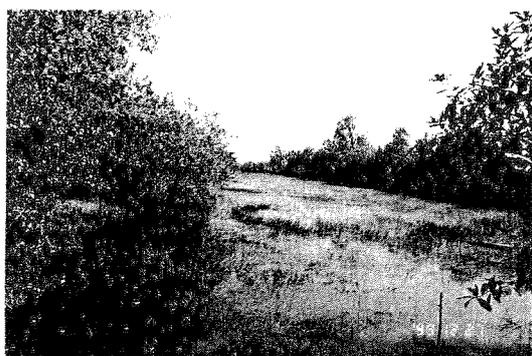
写真4 西側地区の環濠 (1999. 12 久保)

空中写真では低い湿地あるいは水面が直線状に連続し、人工的な構造であることが明瞭である。環濠の幅は約20mほどである（写真4）。さらに、環濠の北西隅では内側に幅20m程度の盛土地が明瞭に認められたが、付近に建造物などの遺構は確認できなかった。

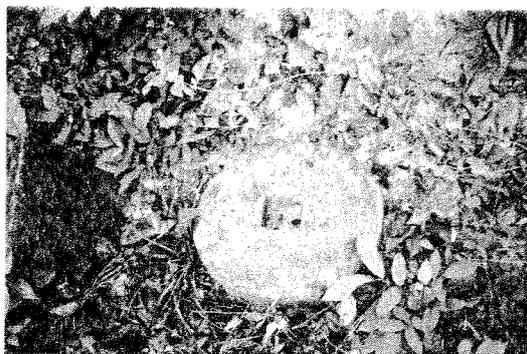
写真8 クナイトゥール マウンドB
正面にある砂岩製ヨニ (1998. 12 古城)

マウンドBとCの祠堂プランは正方形だが、草で覆われているため床中央にあると思われる穴は観察する事ができなかった。両祠堂とも東側に入口の開口がある。マウンドBでは入口に頁岩と思われる石製の階段がつけられており、この前面に石製の円形ヨニおよび砂岩柱が、マウンド斜面にはレンガが散乱している。一方、マウンドCの入口の前にはリントル（まぐさ石）、入口敷き石、四角形のヨニの破片等が散乱している（写真8）。マウンドD祠堂のプランは草に覆われているためよくわからないが、マウンドの形態から見て入口は東にあったと思われる。入口部分にはラテライト製の円柱が立っているが、その円柱を掘り出すために後になってから掘られた穴がある。その穴の北から東側にはこの穴を掘る時掘り出されたと思われるラテライトブロックが多数散乱している。マウンド南西の裾部分にもラテライト製の円柱が立っている。

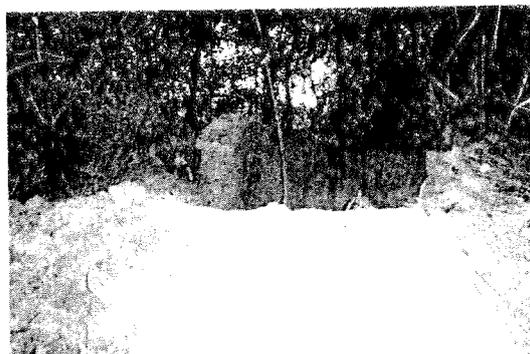
写真10 プラサートクニーサイ正面
(1998. 12 古城)

1998年度に踏査したもので、西区のブラサート タモンの北方にある(2001・2002年度の調査で位置を確認)。藪の中にあるマウンドの中心に祠堂の基部から地下部分のみが残っている(写真10)。東に入口を持つ方形の祠堂(東西253 cm, 南北298 cm, 深さ170 cm)の床中央に、東西143 cm, 南北123 cm, 深さ100 cm以上の穴が掘られている(写真11)。祠堂の壁はラテライトブロック、中央の穴の壁はレンガで作られている。祠堂南東隅の床面から約120 cm程上の所に天井を支えていたと思われる砂岩のフックがついている。入口前面のマウンド斜面には二つの連続した大きな落ち込みがある。マウンドの斜面や下には、装飾のある砂岩片(写真12)、ソーマストラ(砂岩ブロックに溝を掘込んだもの、幅32 cm)(写真13)、砂岩角材(長さ122 cm, 幅31 cm, 厚さ20 cm)、大型ラテライトブロック(縦40 cm, 横37 cm, 厚さ14 cm)等が散乱している。

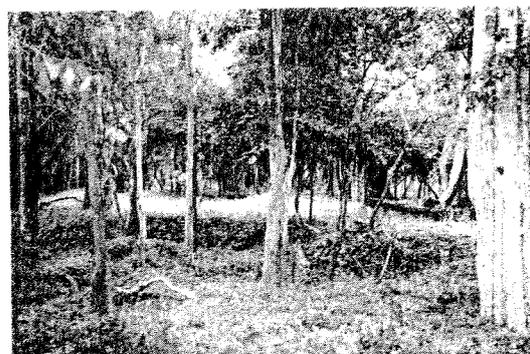
写真14 ソンボープレイクック遺跡のグロリエ
発掘トレンチ (1998. 12 古城)

これら3か所のうち、(1)については現場を踏査して、埋め戻されずに残っている当時の発掘トレンチを実際に確認した(写真14)。トレンチは上に述べた交差点から、道を94 m程北に行った所で道西側の林の中に40 m程入った地点にある。トレンチは南北15 m、幅5 mで三つの発掘区に等分されている。中央の発掘区の東西には、後から拡張したと思われる小発掘区(東西3 m、南北2.5 m)が付け加えられている。トレンチの深さは1 mから1.5 mで壁には陶磁器・素焼き土器片を中心とする多数の遺物が露出している(写真15)。他の二つの発掘箇所については、時間がなく実際に踏査して場所を確認することはできなかったが、話によるとこれら2か所もトレンチが埋め戻されずに残って

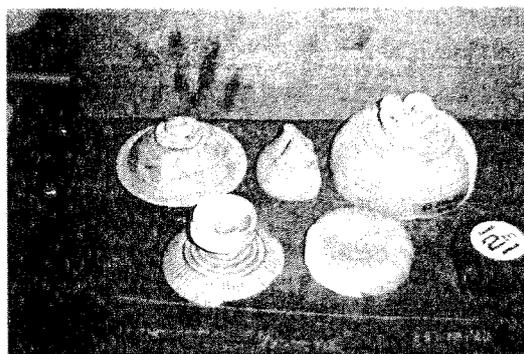
写真 18 グロリエ発掘遺物 クメール陶器
(11-12 世紀; 1998. 12 古城)

遺物は素焼き土器・陶磁器を中心として、用途不明土製品（写真16）、平瓦、石製スタンプ、彫刻のある石片、石板、石棒、石製円盤その他の用途不明石製品、水晶、青銅製リング、鉄の薄板を折曲げたもの他の鉄製品（写真17）、不明鉱石（鉛？）等多彩なものがある。陶磁器の中には完形のものや欠損部分を石膏で復元したもの（いずれも小型の容器に限る）も少数あるが、大部分は破片である。陶磁器には中国製、東南アジア製、およびクメール陶器（おそらく11世紀から12世紀のもの）（写真18）が含まれる。中国製陶磁器には、景德鎮窯（写真19）、龍泉窯、同安窯、徳化窯等で11世紀から14世紀に作られたと思われるものが多く含まれる一方、これより古いと思われるものは唐三彩系（写真20）のものが若干あるだけである。素焼き土器は壺、水差しを中心とするが、注口のあるもの（写真21）、彩文のもの、全面赤色塗彩のもの、沈線、段、隆起線等による文様をもつもの、胎土に植物繊維を多量に混入したもの、非常に厚手で粗製のもの、非常に硬く堅牢なもの等、色々なものが含まれる。

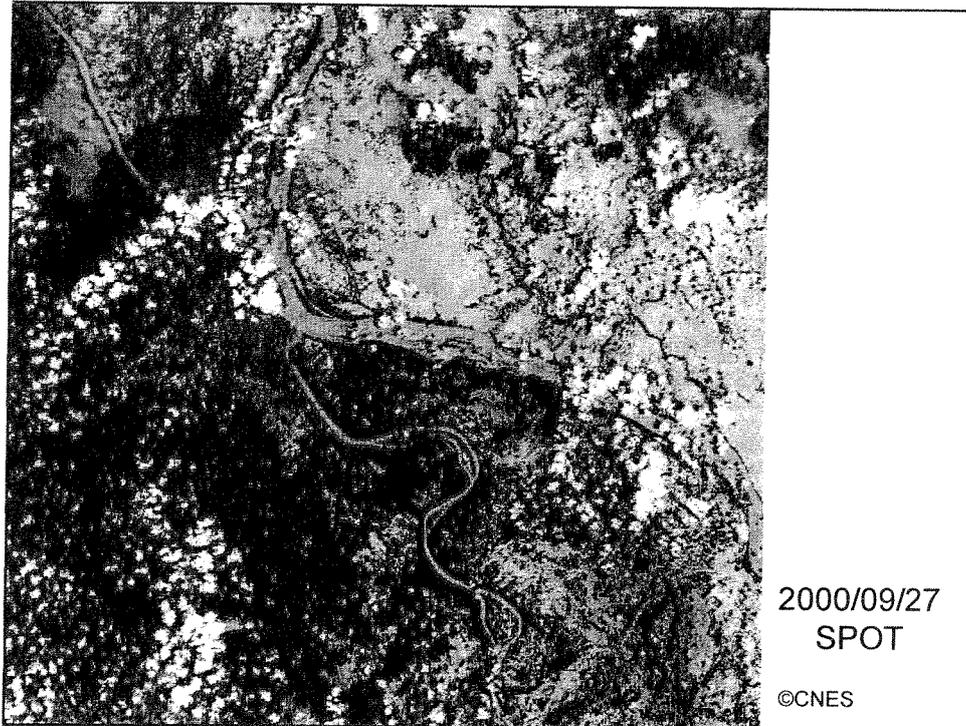
Geomorphologic Features and Floods

- Higher uplands, residual hills and alluvial fan are not inundated
- Natural levees are not inundated
- Back marshes are extensively inundated in the left bank of Mekong
- Flood water flows along the Tonle Sap river (flat and swampy), where Kop Srav Dyke protects Phnom Penh
- Very little area is inundated along the Bassac river with Colmatage channels

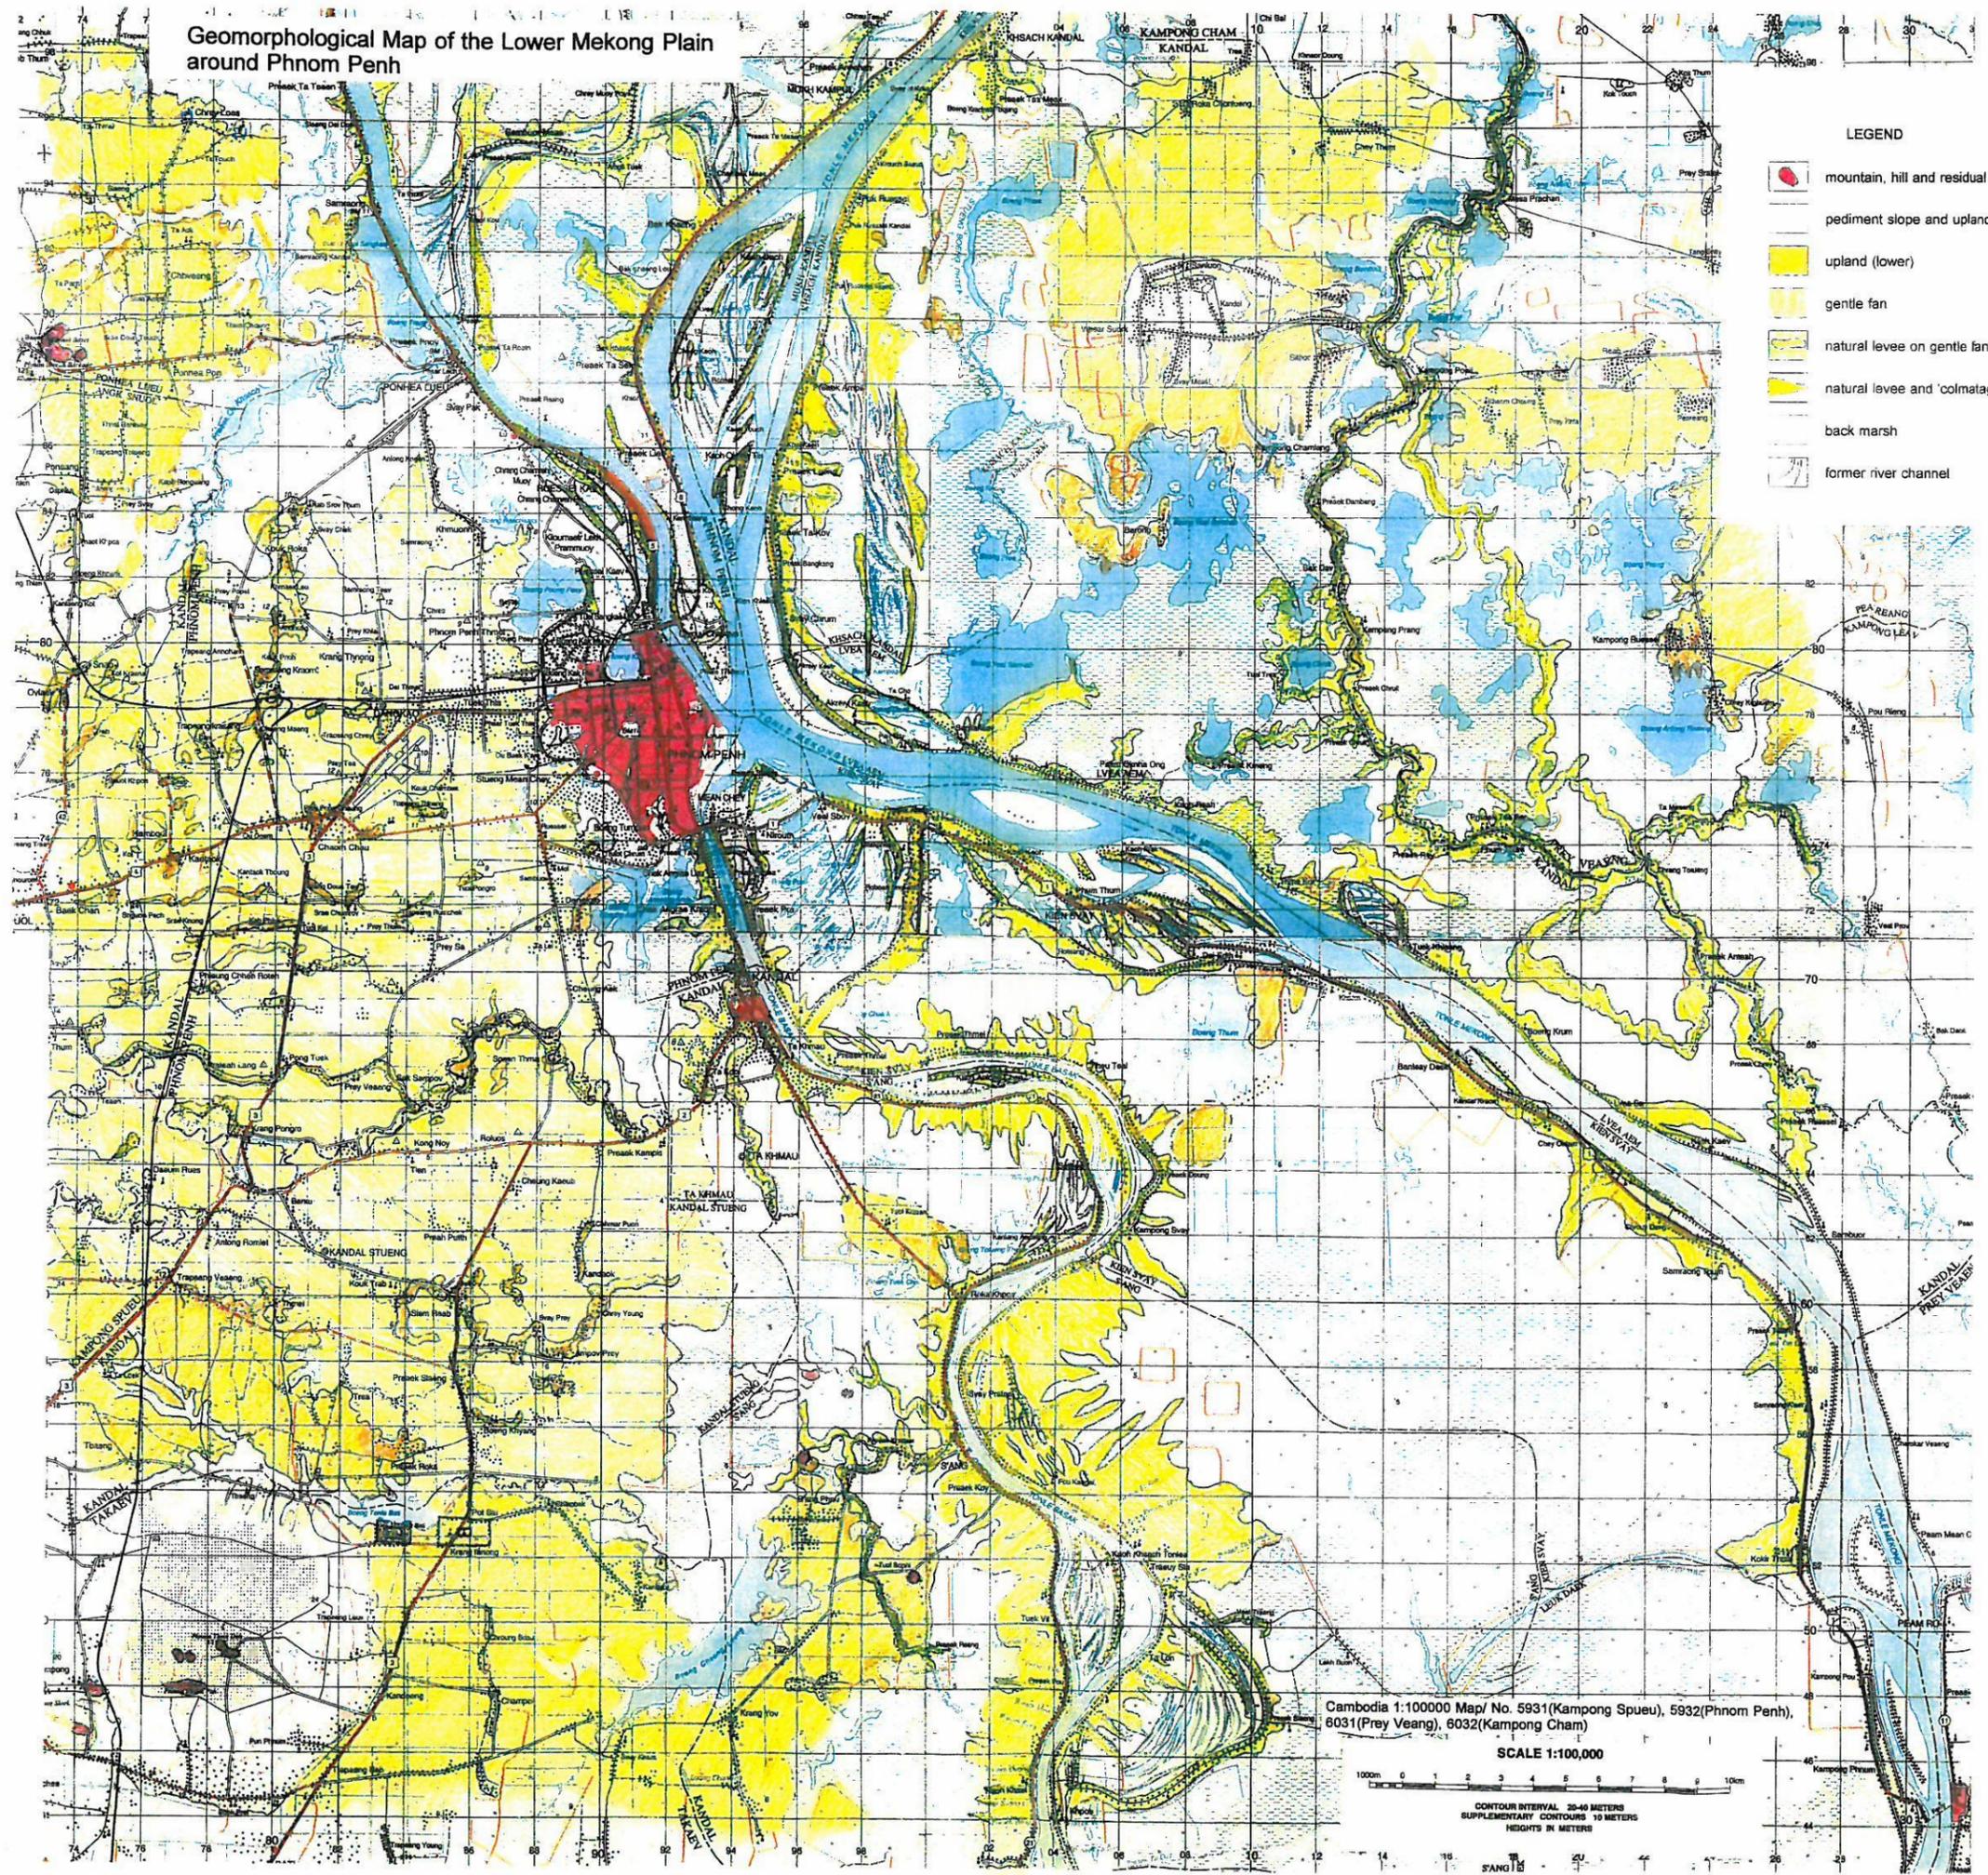
Geomorphological Map of the Lower Mekong Plain around Phnom Penh

- mountain, hill and residual hill
- pediment slope and upland (higher)
- upland (lower)
- gentle fan
- natural levee on gentle fan
- natural levee and 'colmatage' bank
- back marsh
- former river channel
